Fuel Cell Power Plant Initiative

Final Report - Volume I Solid Oxide Fuel Cell/Logistics Fuel Processor 27 kWe Power System Demonstration for ARPA

November 1997

Prepared for the NASA Lewis Research Center Under Contract #NAS3-27022

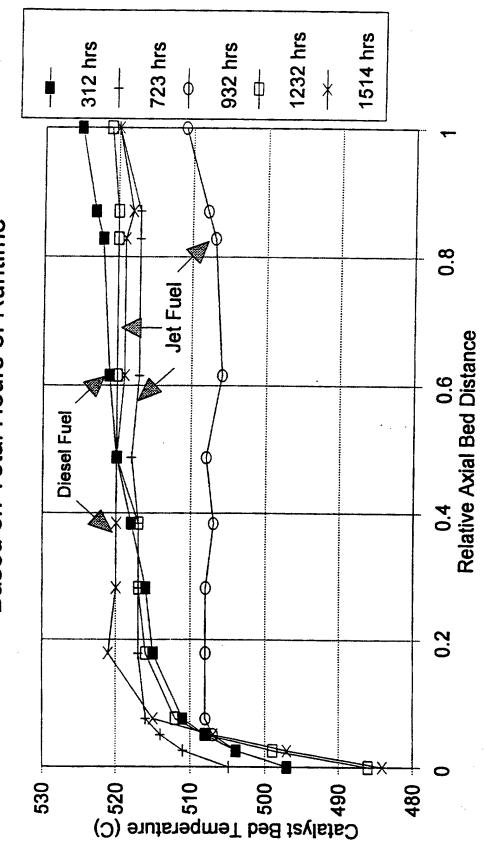
During the last 550 hours of operation, some deactivation of the prereformer catalyst was seen. This is evidenced by the movement of the temperature profile. As seen no progressive movement of the profile is seen for the first 2300 hours of operation. The last 550 hours of prereformer run time correspond to the addition of thiophene to the diesel feed. No explanation is available as to why the HDS section did not completely remove the sulfur after thiophene was added.

The oxidation of the nickel within the catalyst is typically caused by the influx of steam without the presence of hydrocarbons. In the analysis of the catalyst, the upper portion of the catalyst bed was noted as containing excessive amounts of oxidized nickel. It is possible that during the PLC shutdown of December 7, 1995, steam, without diesel, was injected into the prereformer. Because it was a control system failure, no data are available on the cause or sequence of events following the shutdown. This tends to explain the significant deactivation of the top portion of catalyst at 1514 hours, as well as presence of oxidized nickel in the same area.

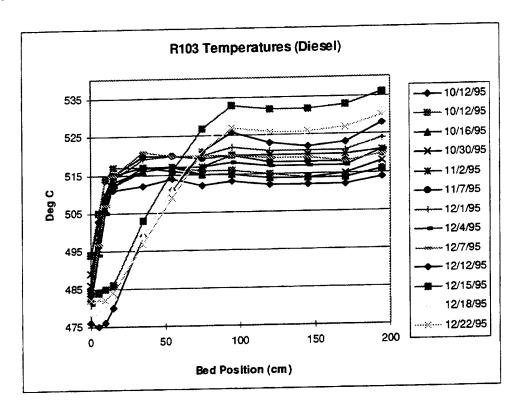
R-103 Temperatures

On 12/7/95 the LFP skid tripped due to a PLC halt. After the restart, the R-103 temperature profile had changed; the drop in upper bed temperatures indicating that the top portion of the catalyst bed had become deactivated. The following graph shows the change in the R-103 temperature profile following the restart.
